CASE STUDIES

LATERAL WINDOW SINUS AUGMENTATION

Case from Dr Andrew Fish, Jersey Channel Islands

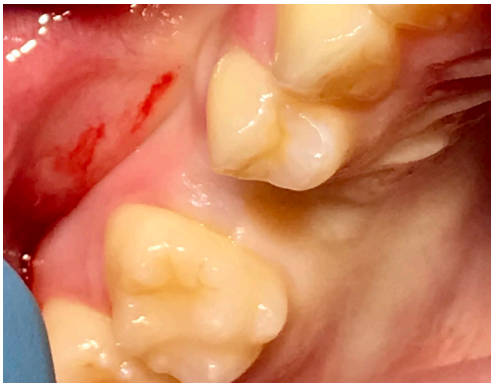
2. Implant removed and site allowed to heal, loss of buccal profile

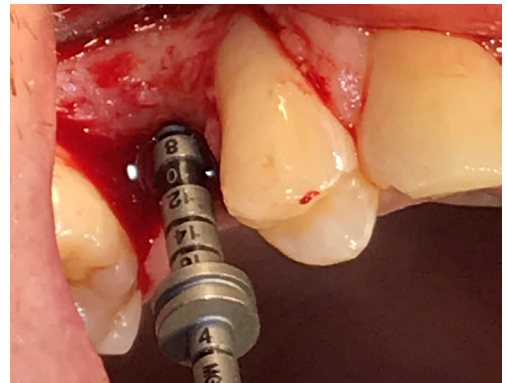
3. Prepare osteotomy and checking depth, sinus augmentation required

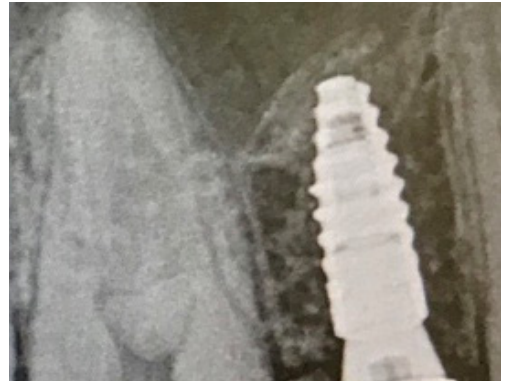
7. Loaded 12 months
